DUMONT BOROUGH HALL

Prepared By: County of Bergen
Department of Health Services
Melissa Johnson, MS, Industrial Hygienist

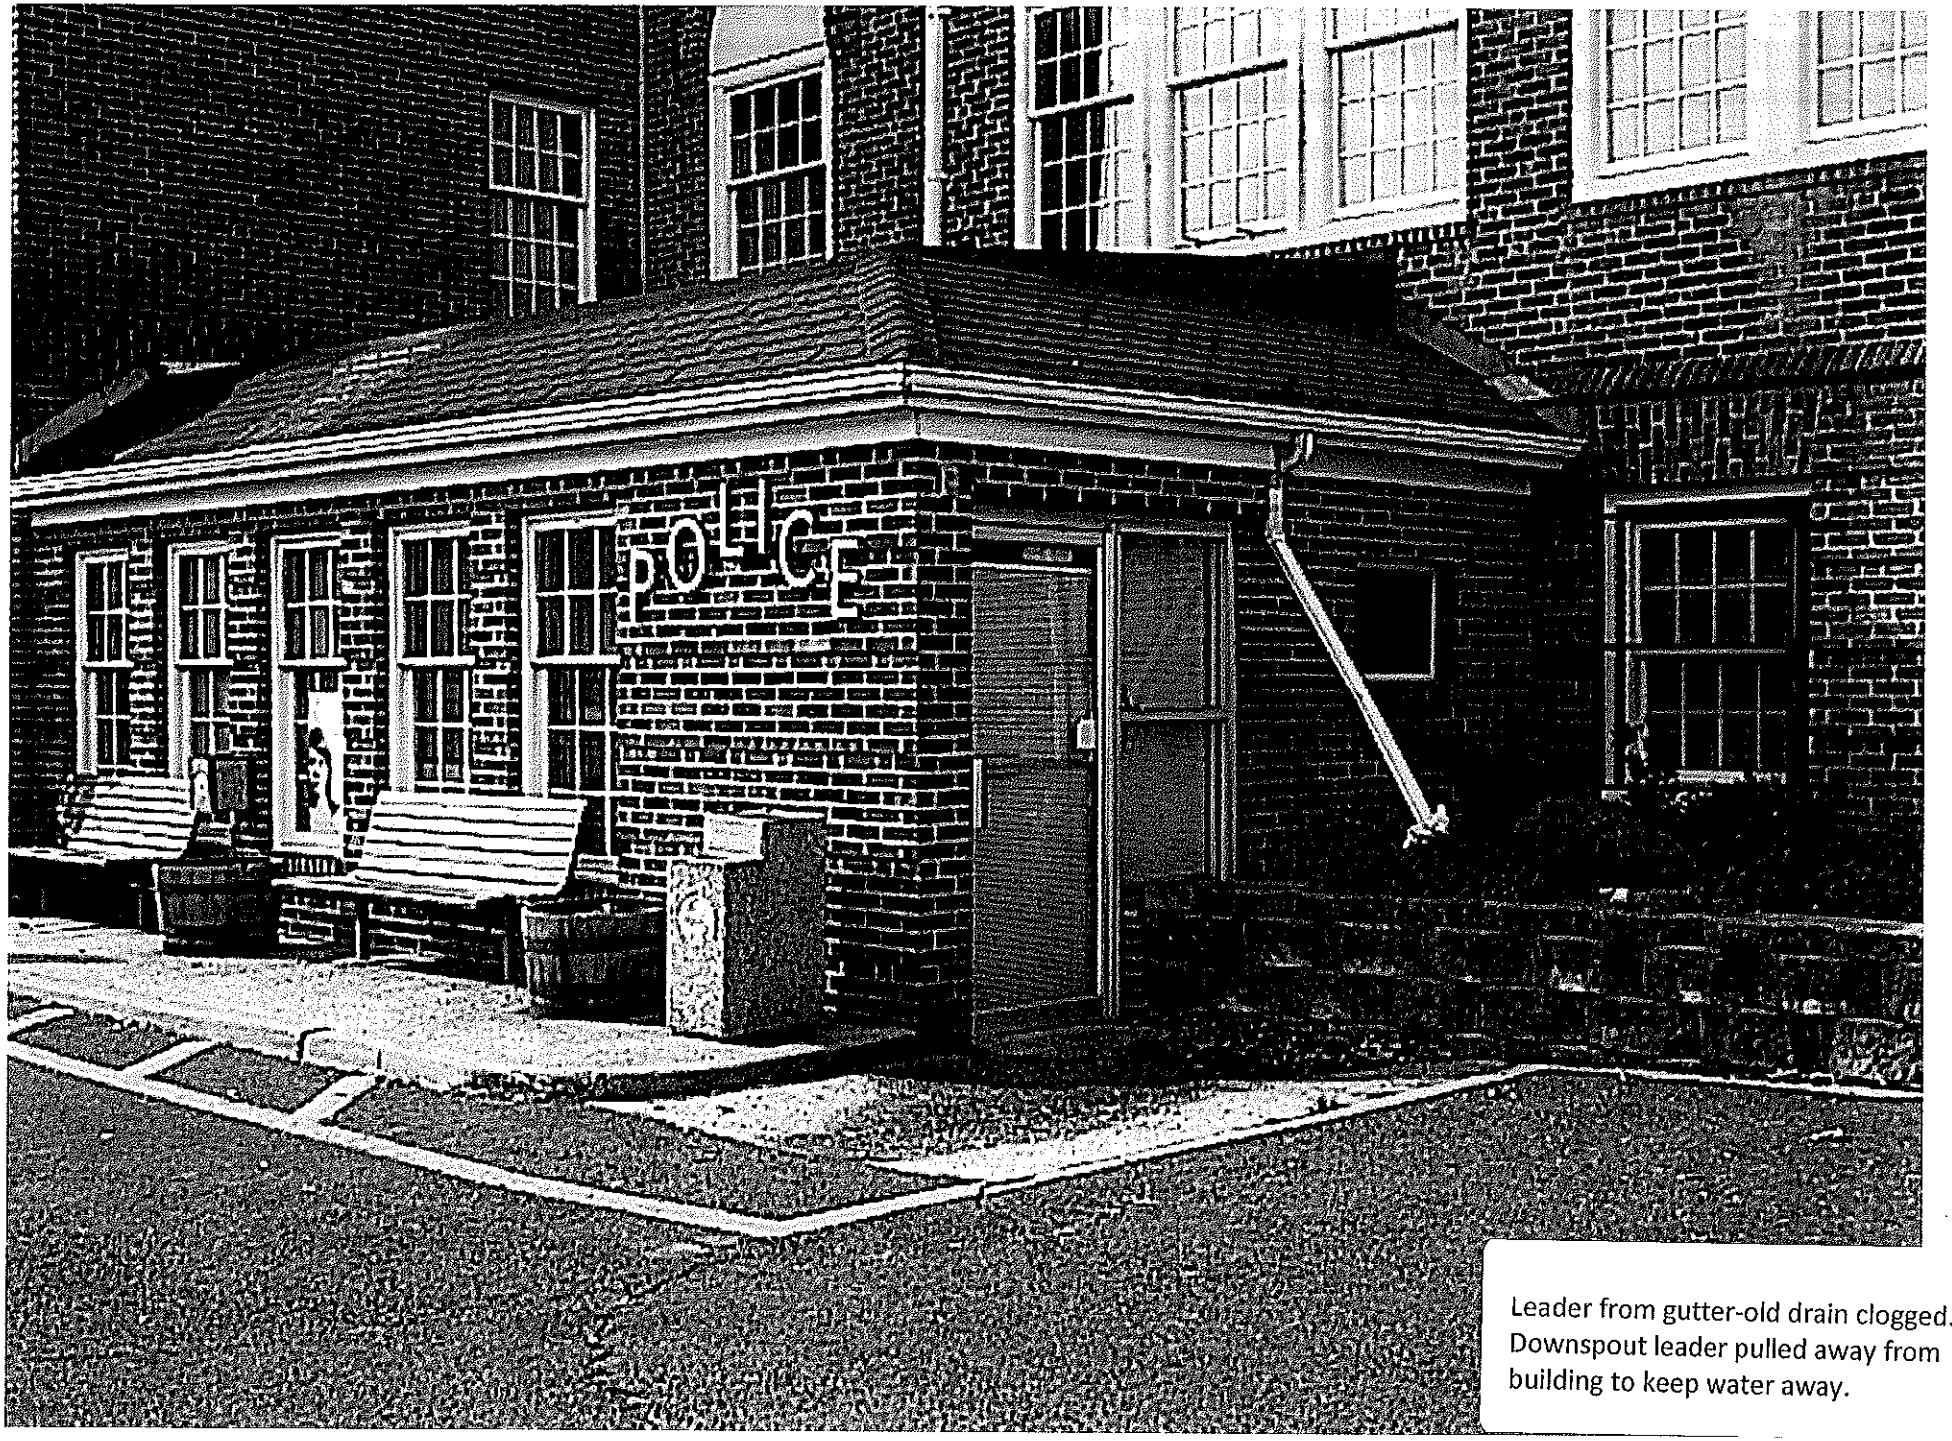
Leader from gutter-old drain clogged. Downspout leader pulled away from building to keep water away.
